HOME REPORT

Place Farm Largs Road

Kilbirnie
KA25 7LH

Single Survey

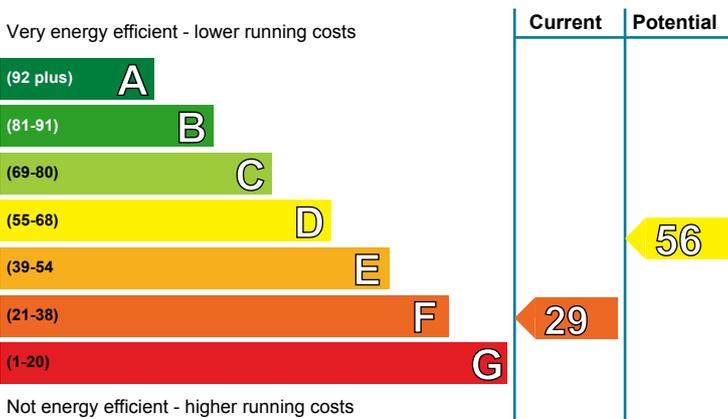
Energy Efficiency Rating

This graph shows the current efficiency of your home, taking into account both energy efficiency and fuel costs. The higher this rating, the lower your fuel bills are likely to be.

Your current rating is **band F (29)**. The average rating for EPCs in Scotland is **band D (61)**.

The potential rating shows the effect of undertaking all of the improvement measures listed within your recommendations report.

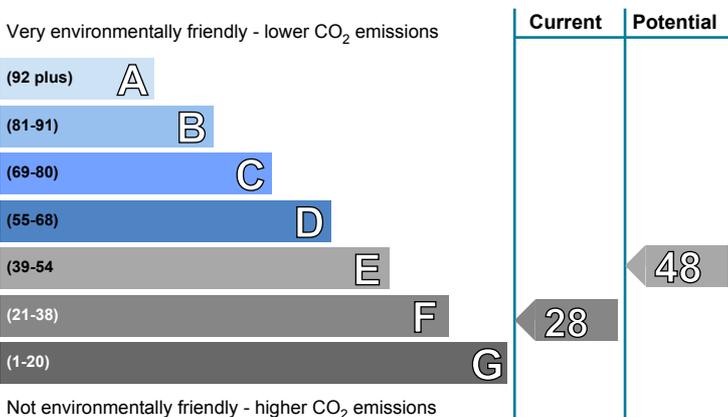
Environmental Impact (CO₂) Rating

This graph shows the effect of your home on the environment in terms of carbon dioxide (CO₂) emissions. The higher the rating, the less impact it has on the environment.

Your current rating is **band F (28)**. The average rating for EPCs in Scotland is **band D (59)**.

The potential rating shows the effect of undertaking all of the improvement measures listed within your recommendations report.
