Home Report

27 Bank Street
Aberfeldy PH15 2BB

Single Survey

Property Address	27 Bank Street Aberfeldy PH15 2BB
Customer	Mr J Will
Prepared by	Graham + Sibbald LLP
Date of Inspection	18/04/2025

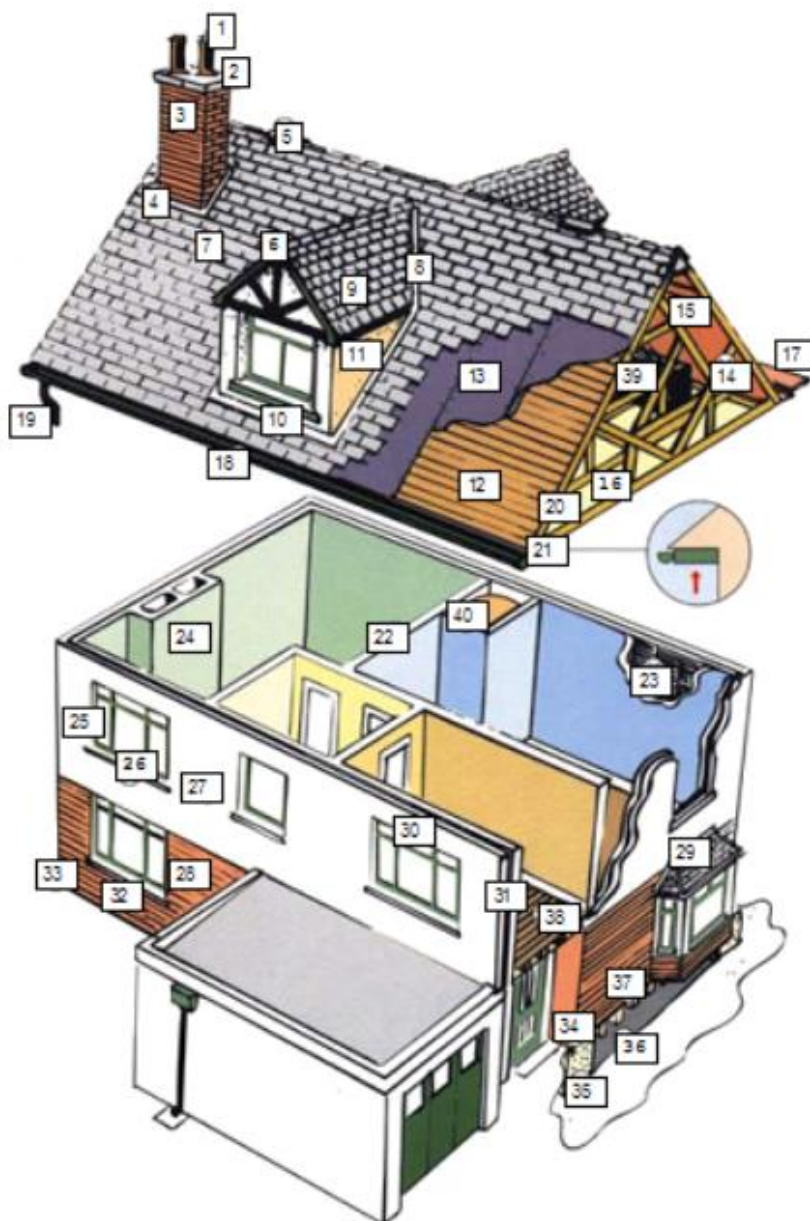
Sectional diagram showing elements of a typical house

1	Chimney pots
2	Coping stone
3	Chimney head
4	Flashing
5	Ridge ventilation
6	Ridge board
7	Slates / tiles
8	Valley guttering
9	Dormer projection
10	Dormer flashing
11	Dormer cheeks
12	Sarking
13	Roof felt
14	Trusses
15	Collar
16	Insulation
17	Parapet gutter
18	Eaves guttering
19	Rainwater downpipe
20	Verge boards / skews
21	Soffit boards
22	Partition wall
23	Lath / plaster
24	Chimney breast
25	Window pointing
26	Window sills
27	Rendering
28	Brickwork / pointing
29	Bay window projection
30	Lintels
31	Cavity walls / wall ties
32	Subfloor ventilator
33	Damp proof course
34	Base course
35	Foundations
36	Solum
37	Floor joists
38	Floorboards
39	Water tank
40	Hot water tank

Reference may be made in this report to some or all of the above component parts of the property. This diagram may assist you in locating and understanding these items.
